PHOTOGRAPHS OF SUBJECT PROPERTY

236 Bolivar Street – University Lofts Apartments

The following improvement description is based on a physical inspection of the subject property on November 19, 2010 and is supported by building plans and specifications for the property.

E-01.01- Photographic Record

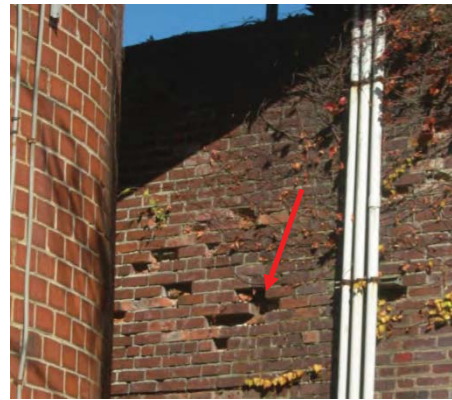
Photo 10- Deterioration and spalling of bricks in electrical vault wall due to water intrusion

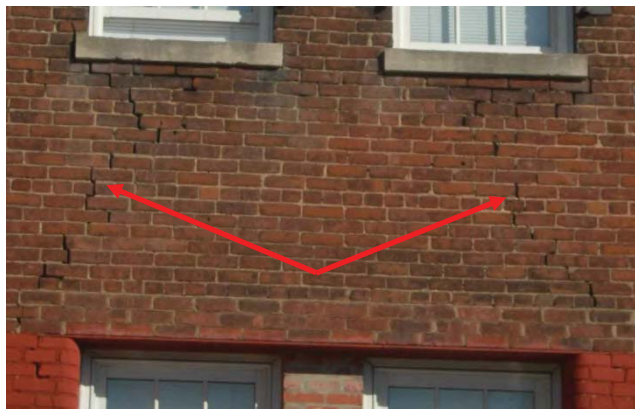
Photo 15-. South-SE elevation – Crack repair needed between 1st and 2nd floors

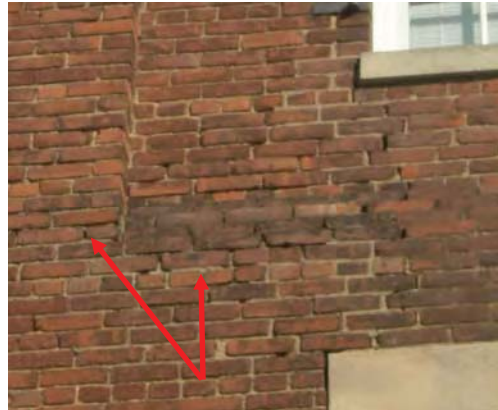
Photo 16- South elevation – Crack repair and tuck pointing needed.

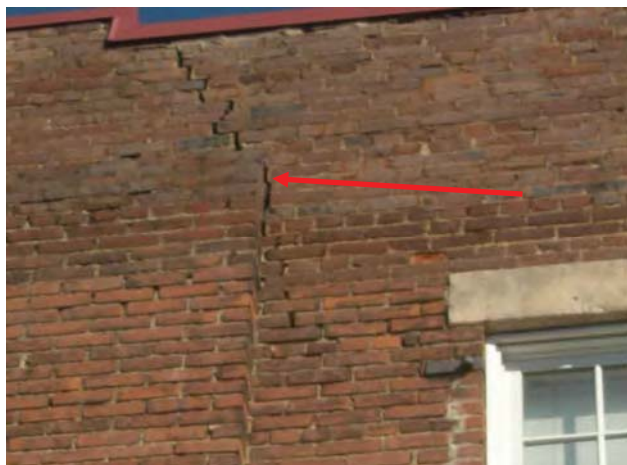
Photo 17- South-SE corner cracking continues 3rd floor to roof parapet

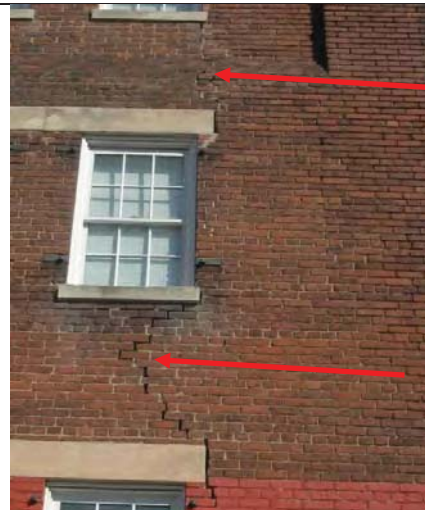
Photo 18- South-SE corner structural crack between 1st and 2nd floor & 2nd to 3rd floor

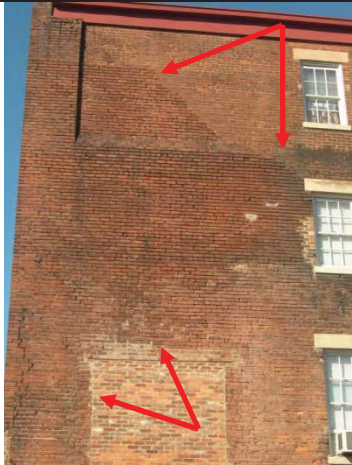
Photo 21- East-SE corner – 80% tuck pointing needed plus significant structural cracking

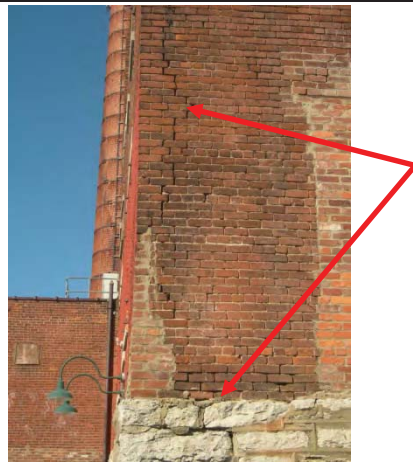
Photo 22- East-SE corner close up of structural crack continuing down into stone foundation

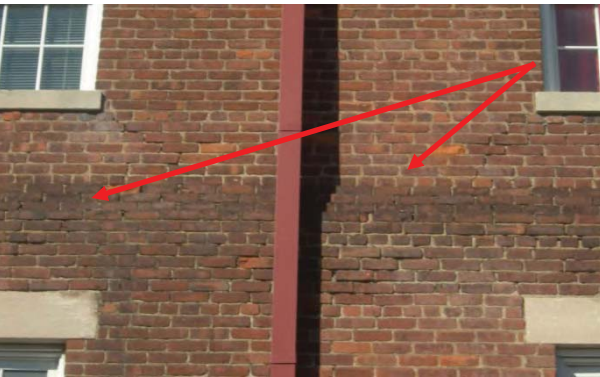
<p>Photo 27- East elevation structural cracks and tuck pointing needed between 2nd & 3rd Flr.</p>	<p>Photo 28- East-NE Elevation has structural crack in brick façade between 1st thru 3rd floor.</p>

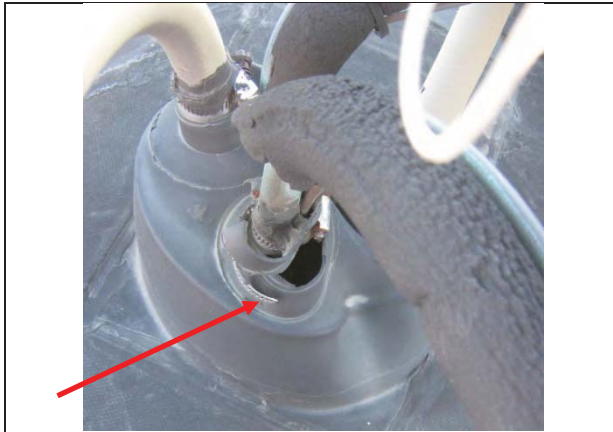
Photo 37 – separation of roof membrane at refrigerant line penetration of roof.
