PHOTOGRAPHS OF SUBJECT PROPERTY

236 Bolivar Street – University Lofts Apartments

The following improvement description is based on a physical inspection of the subject property on November 19, 2010 and is supported by building plans and specifications for the property.

E-01.01- Photographic Record

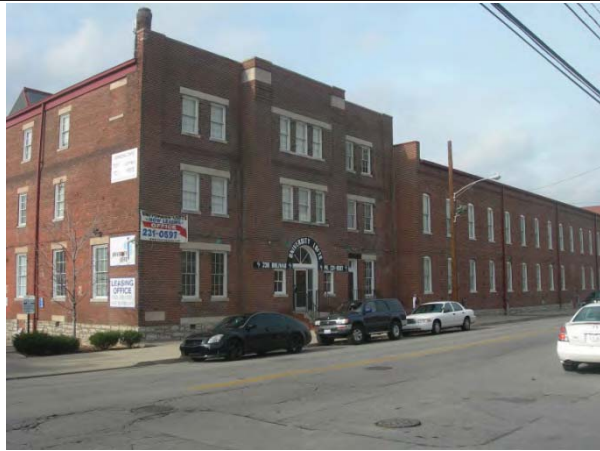
Photo 1 – North Elevation along Bolivar Street is generally in good condition.

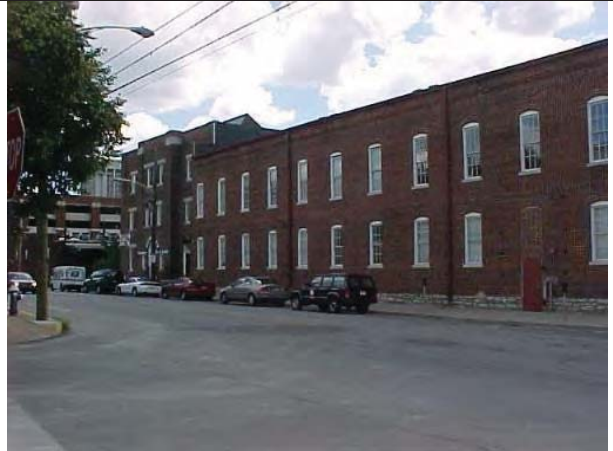
Photo 2 – North Elevation along Bolivar Street is generally in good condition

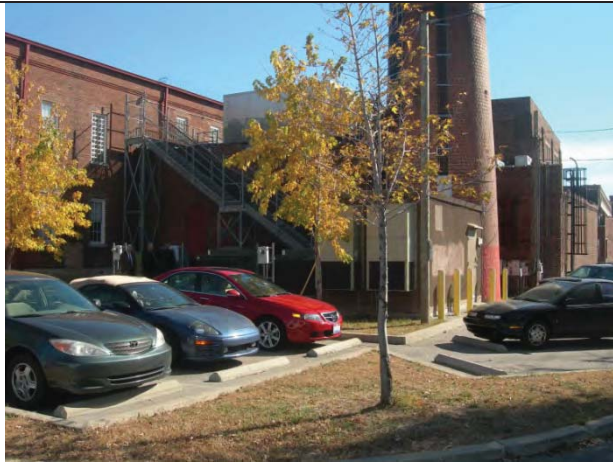
Photo 9 – Electrical transformers, electrical vault and smoke stack west elevation

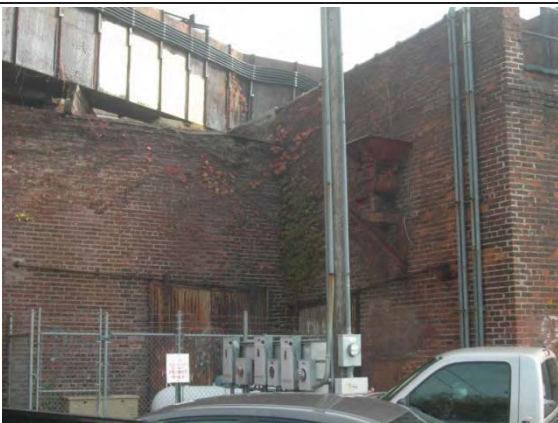
Photo 11- Electrical vault on left and boiler on right.

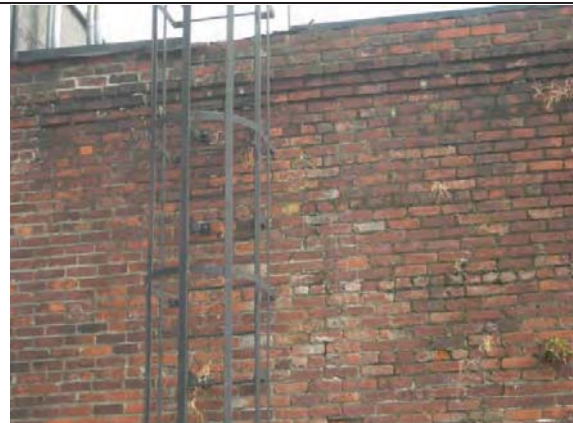
Photo 12- Old boiler room wall has multiple locations with plants growing on vertical face which means significant intrusion of water into mortar joints.

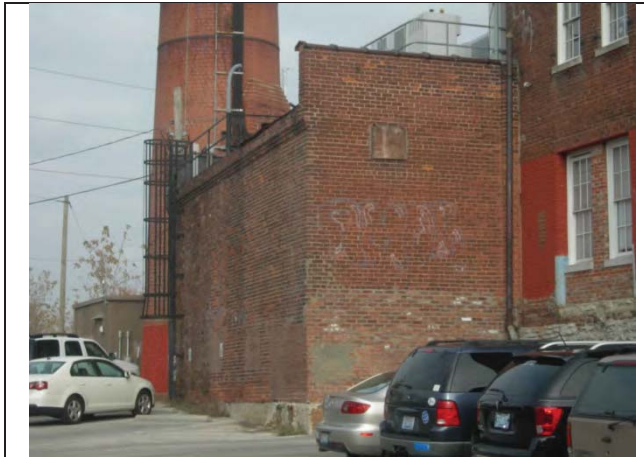
Photo 13- South elevation at old boiler for building.

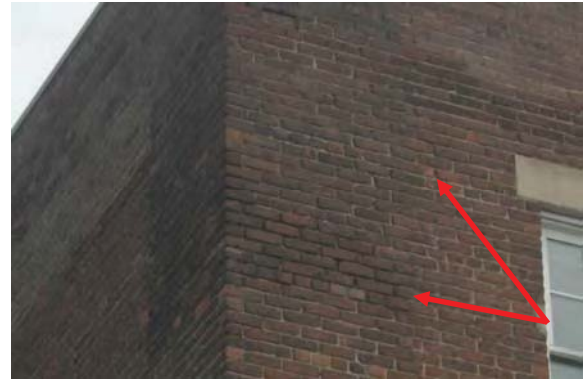
Photo 14 – South-SW 3rd floor corner needs masonry tuck pointing

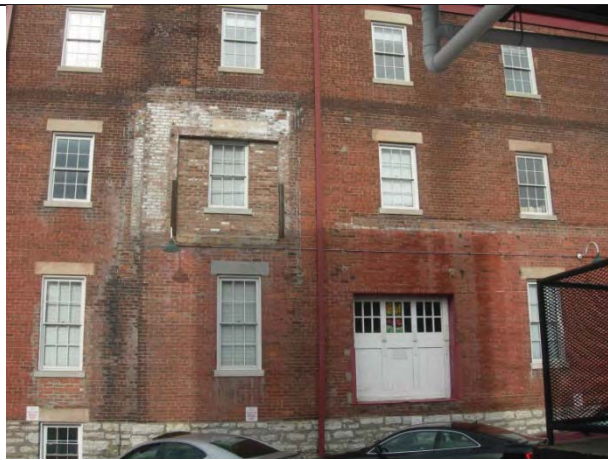
Photo 23- Partial East elevation showing bridge and old canopy

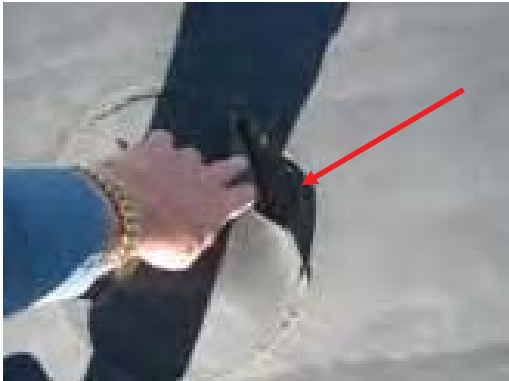
Photo 35- separation of roof membrane at penetration

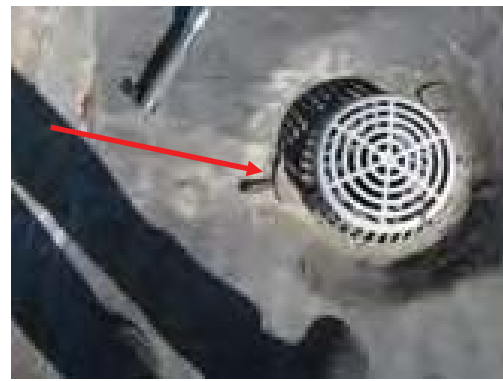
Photo 36- separation of roof membrane at roof drain penetration

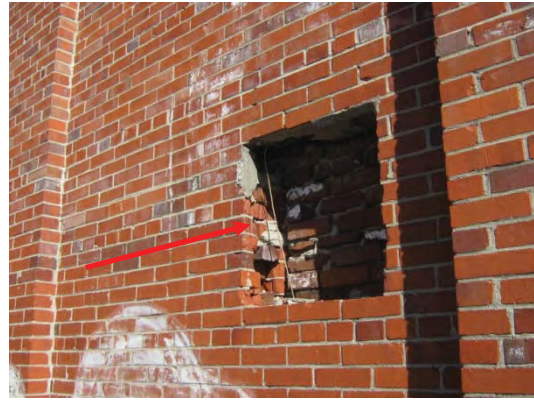
Photo 38 - Recesses in parapet walls allowing water intrusion into parapet wall.

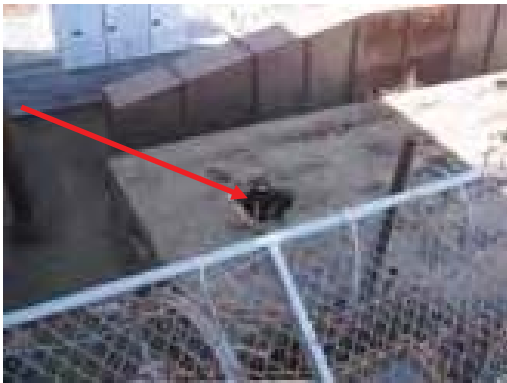
Photo 39- Hole in roof of east in of boiler room.

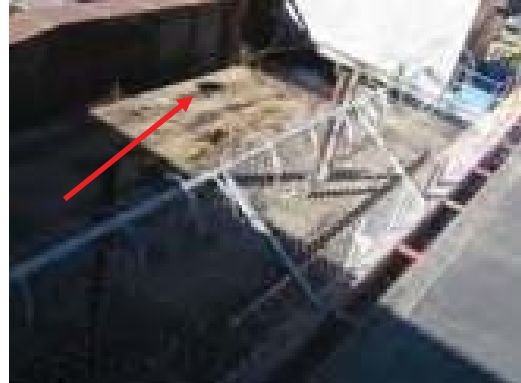
Photo 40- Hole in roof of west end of boiler room.

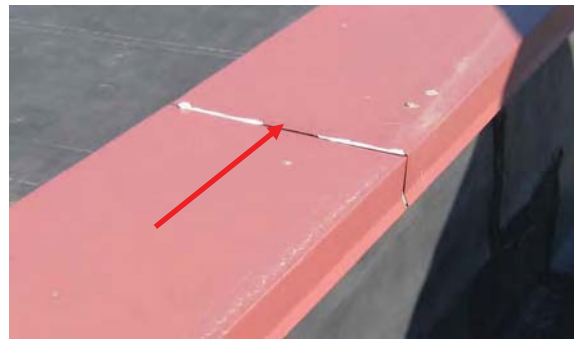
Photo 42- seams at parapet flashing need re-caulking

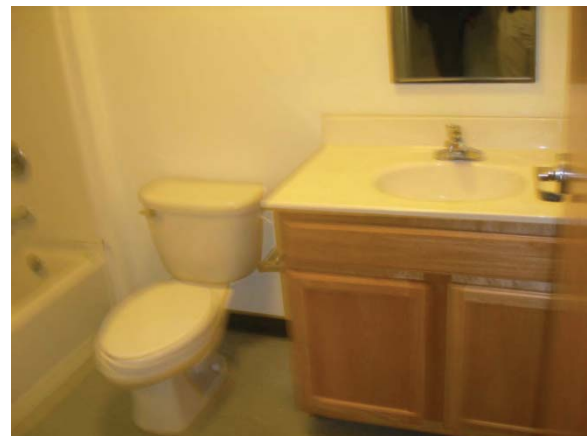
Photo 60- Typical apartment bathroom
