**University Lofts
Facility Condition Assessment**

January 2011

UK Physical Plant Division

Section 'A' is an Executive Summary of findings for University Lofts, Section 'B' documents findings and observations from the tour, Section 'C' addresses possible conversion for Fine Arts, Section 'D' addresses Property Appraisals and Section 'E' has the Appendices..

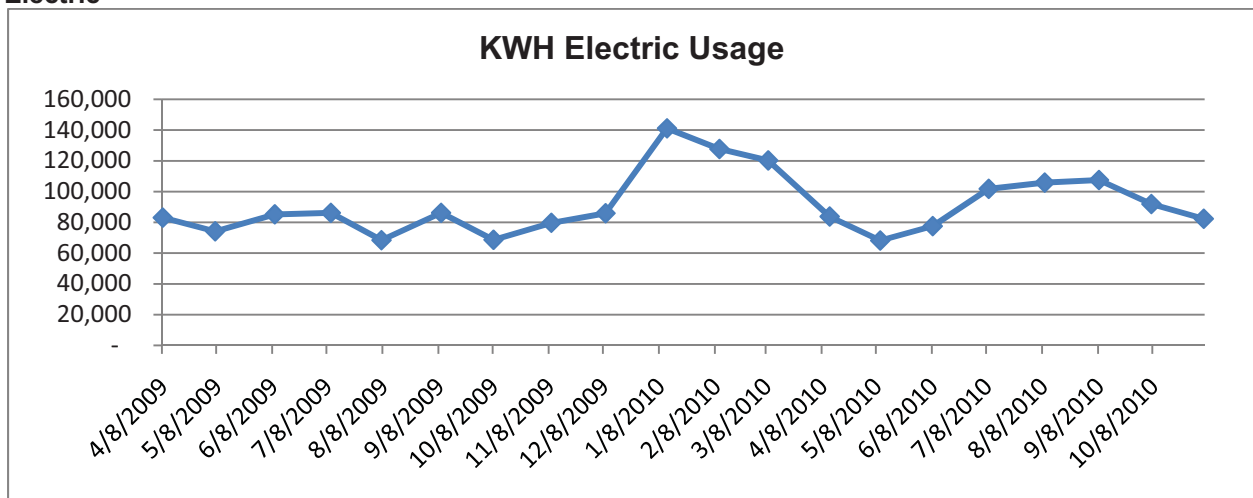
Electric

Observations / Comments:

- The building is all electric for heating and cooling. Three years of electrical usage cost data was provided by Rob McGoodwin's staff:

2010 - \$62,900.64 (Jan. – Sept.)

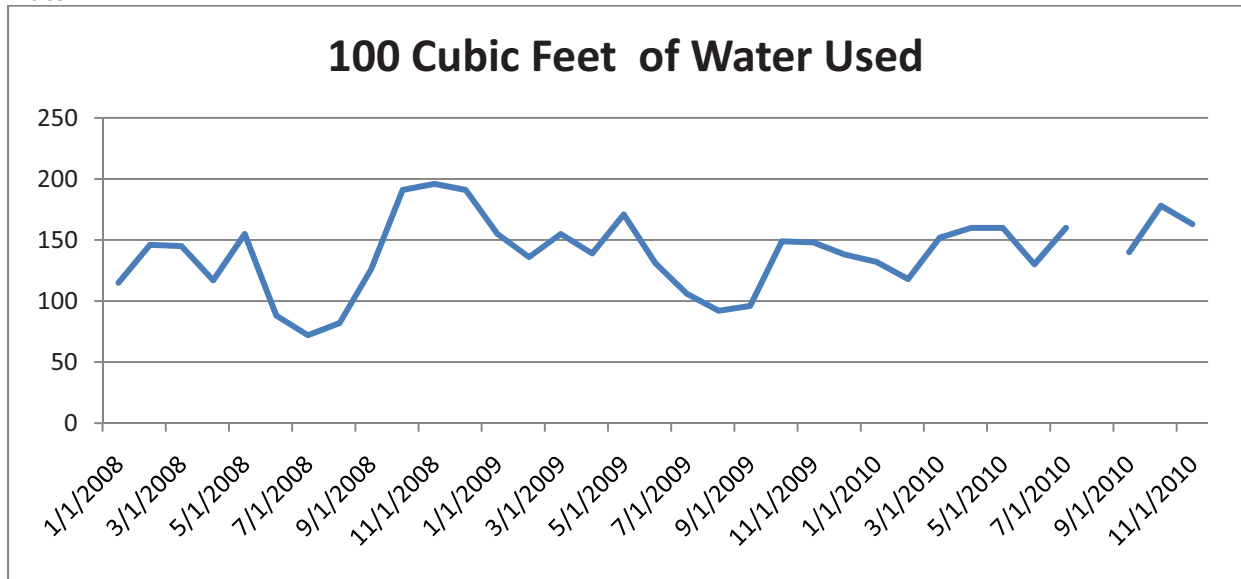
Water

Observations / Comments:

- Three years of water usage cost data was provided by Rob McGoodwin's staff.
