PHOTOGRAPHS OF SUBJECT PROPERTY

236 Bolivar Street – University Lofts Apartments

The following improvement description is based on a physical inspection of the subject property on November 19, 2010 and is supported by building plans and specifications for the property.

E-01.01- Photographic Record

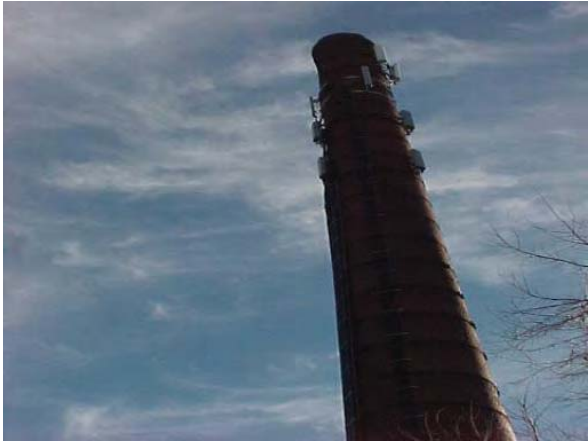
<p>Photo 29- East-NE Elevation</p>	<p>Photo 30 – Smokestack</p>
